Evaluation of Electronic Registering Fareboxes

Prepared by
Booz-Allen & Hamilton, Inc.

Final Report
January 1984

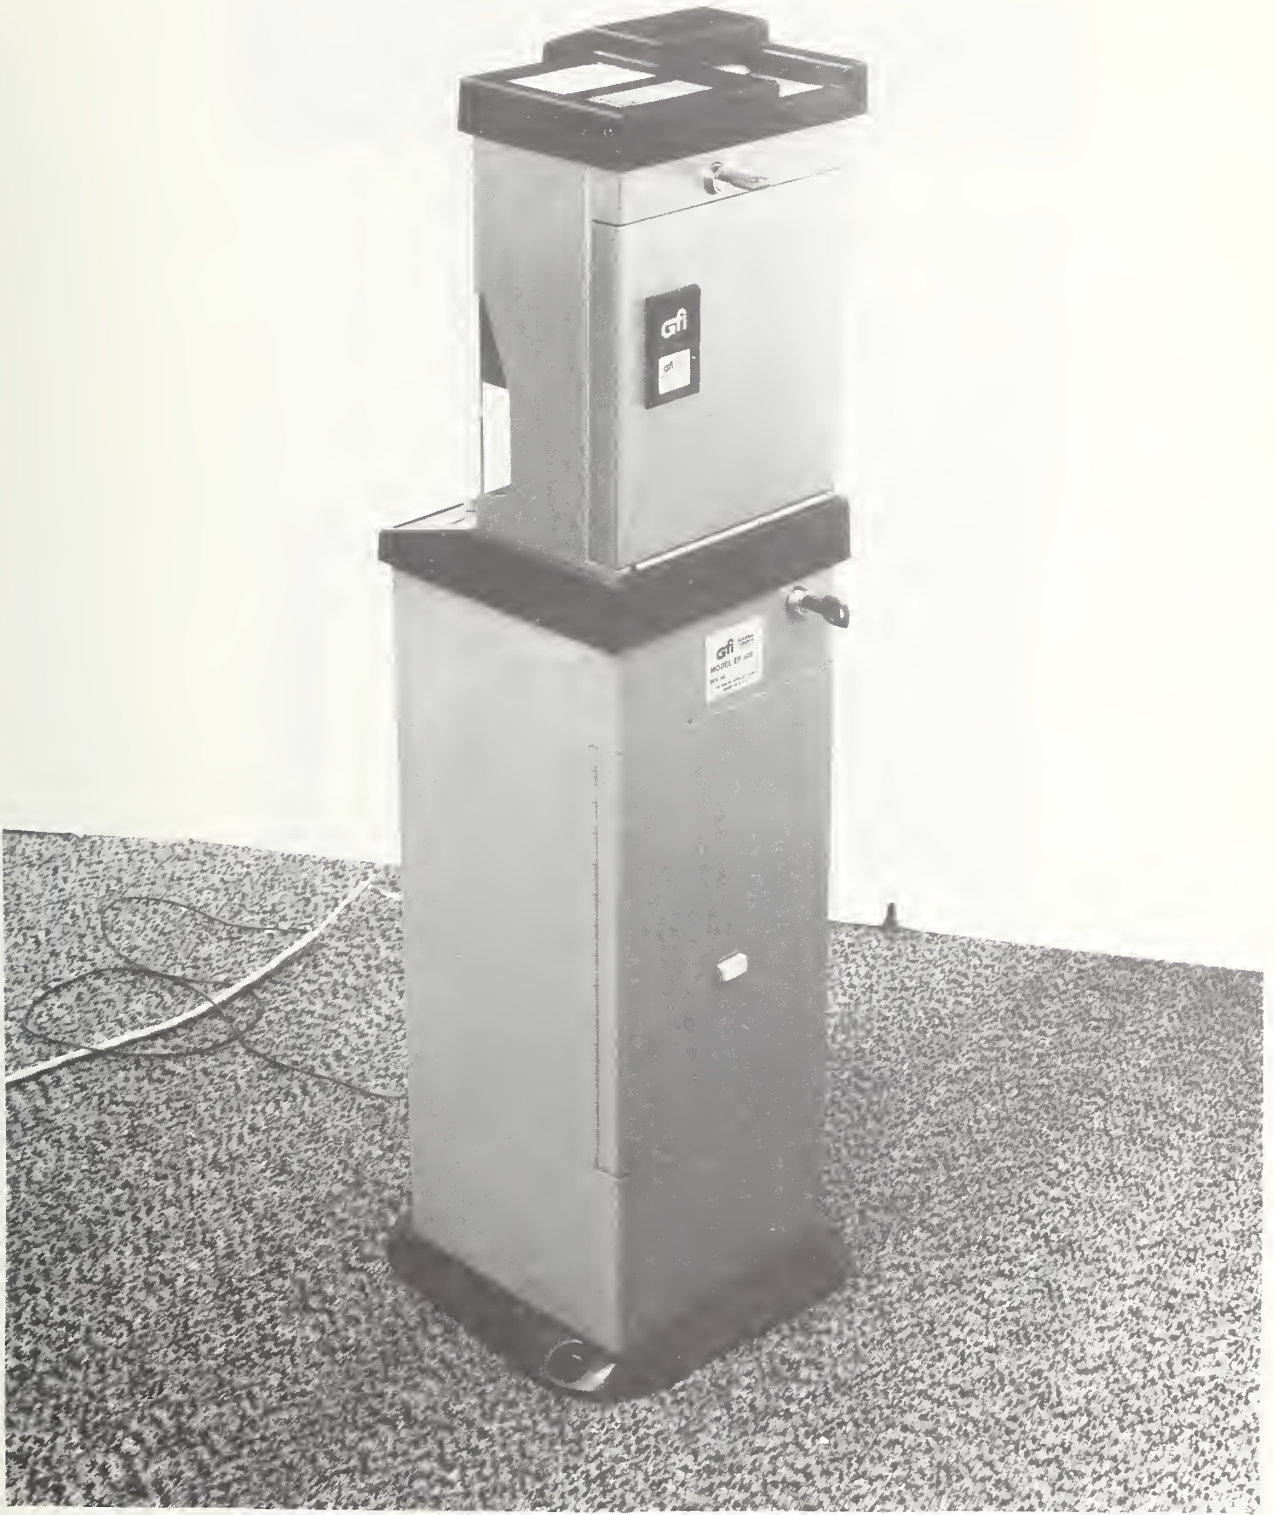
FIGURE 2-1. VIEW OF GFI FAREBOX FACING THE PASSENGER

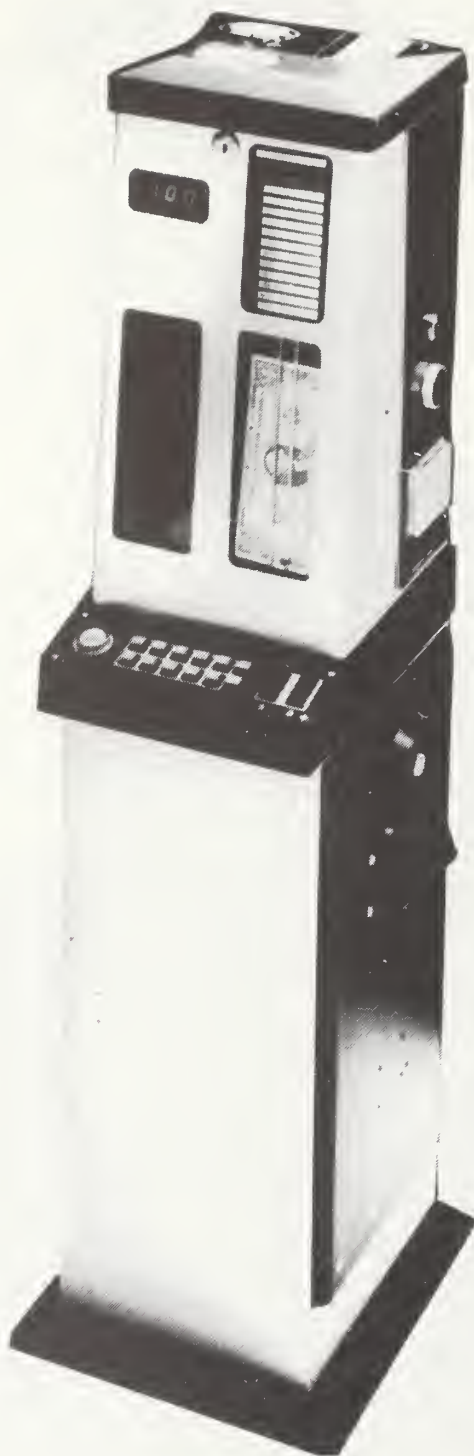
FIGURE 2-2. VIEW OF DUNCAN FAREBOX FACING THE BUS DRIVER

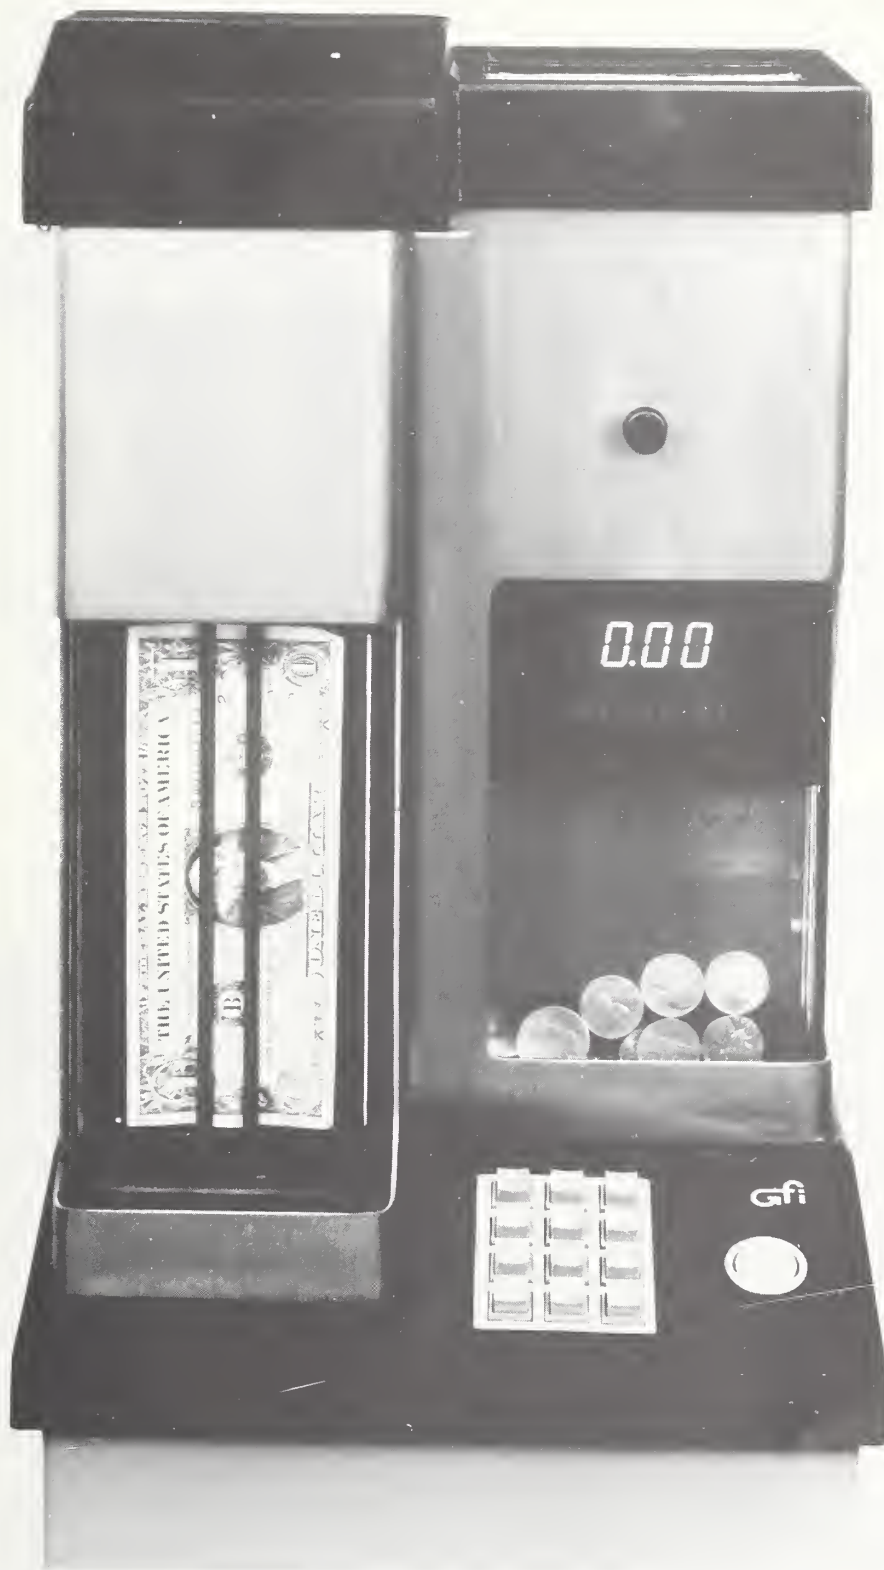
FIGURE 2-3. FARE DISPLAYED TO BUS DRIVER ON GFI FAREBOX

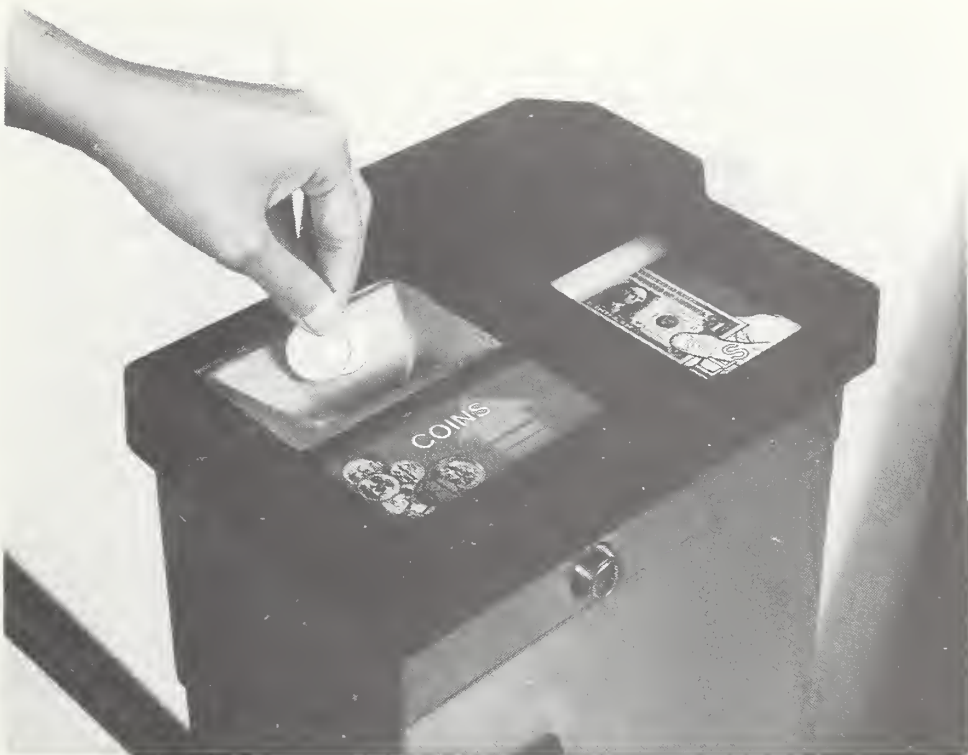
FIGURE 2-5. COIN SLOT ON GFI FAREBOX

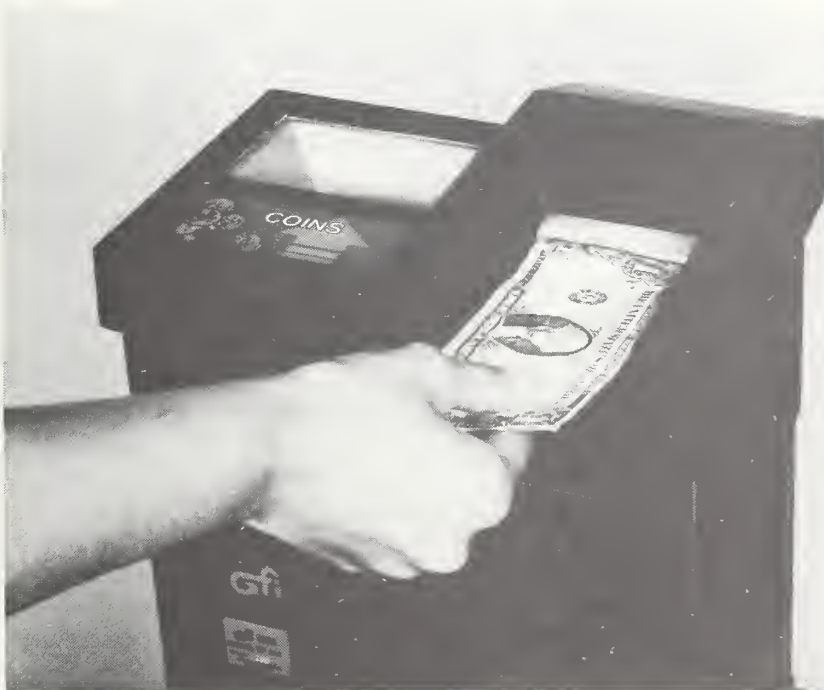
FIGURE 2-6. BILL ACCEPTOR ON GFI FAREBOX

Once inserted into the bill slot, the presence of the bill is detected by micro-switches in the Duncan farebox and a photocell array in the GFI farebox. The micro-switches or photocells measure the length and width of paper inserted to identify it either as a bill or a ticket. If the paper is approximately 6 inches long, the farebox will identify it as a dollar bill. The mechanism cannot distinguish between a \$1, \$2 or \$5 bill; all will register as a \$1 bill. The inserted paper is displayed on an illuminated plate for driver verification that the currency is a true dollar bill or true ticket.

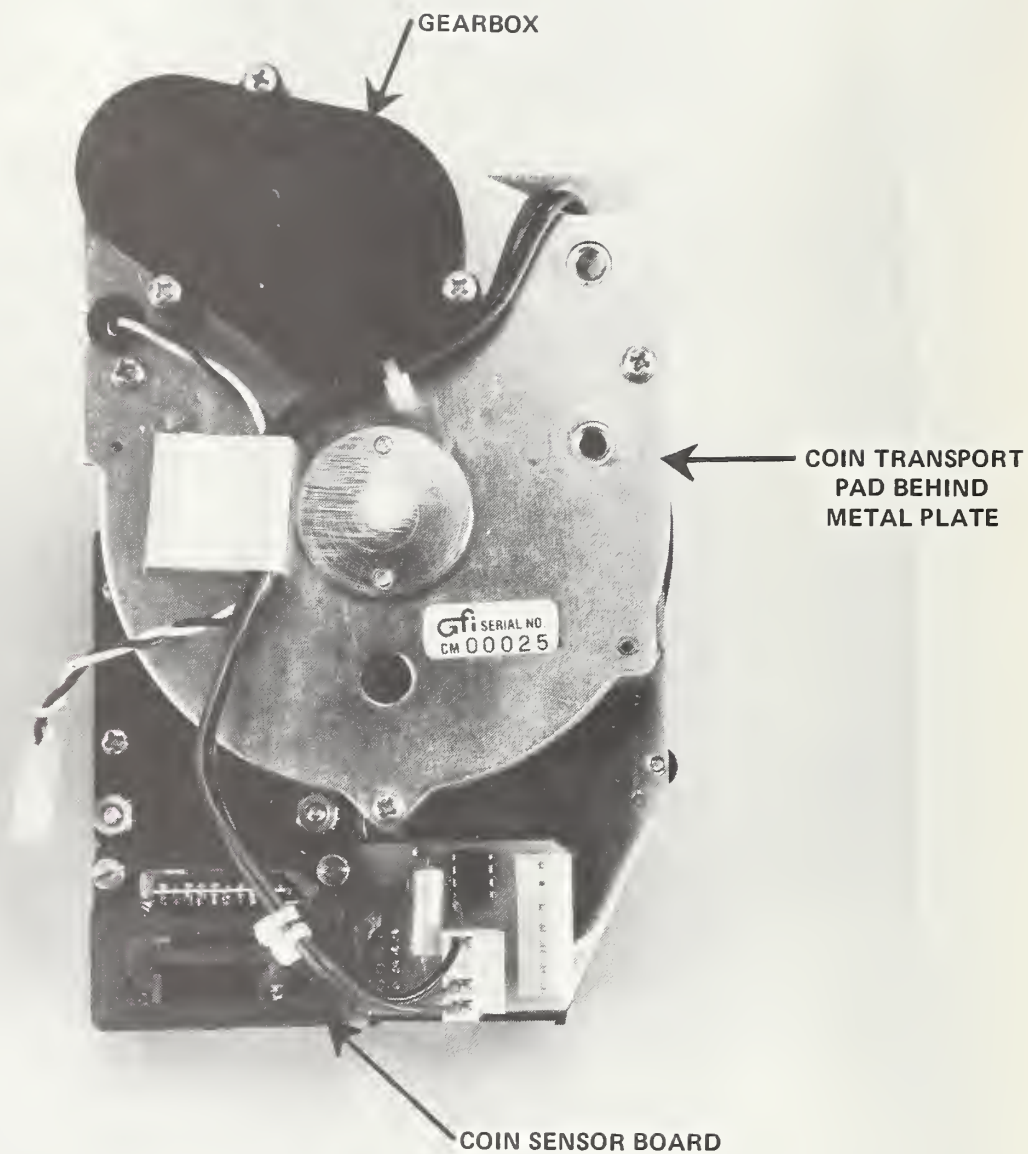
FIGURE 2-8. GFI COIN MECHANISM

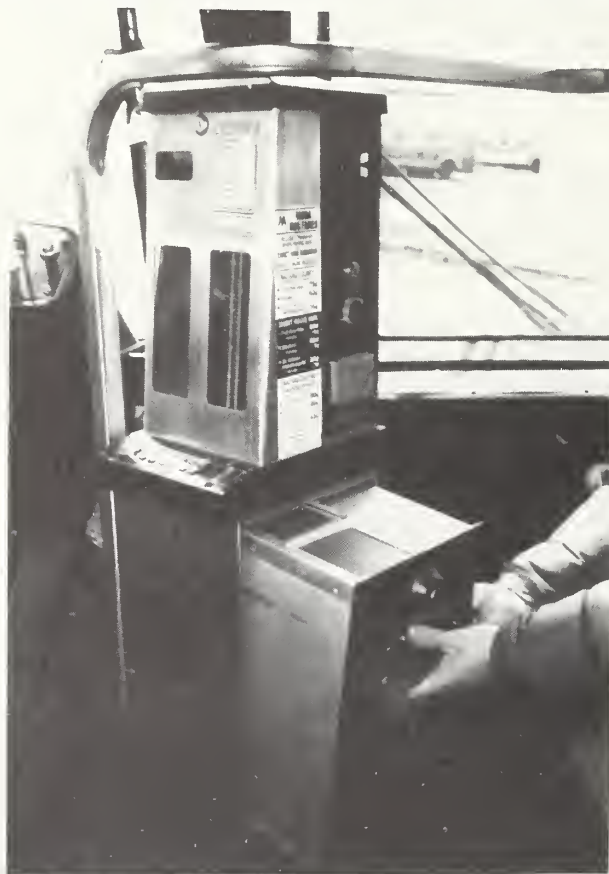
FIGURE 2-11. DUNCAN QUANTAFARE CASHBOX

The Duncan Quantafare and GFI Dualport cashboxes have two separate compartments--one to hold coins and one to hold dollar bills. A dual chamber cashbox is shown in Figure 2-11. The Duncan Quantafare cashbox

is designed to hold a maximum of 600 bills, assuming the bills are inserted correctly into the bill acceptor and they stack properly in the cashbox. The GFI Dualport cashbox is designed to hold a maximum of 400 bills. The stacked configuration of the bills is not preserved when the cashbox is emptied into a vault (cashbox) receiver. According to GFI, the bills typically fall into a heap when the cashbox is emptied. This heap of bills is then manually removed from the vault receiver, counted and re-stacked.

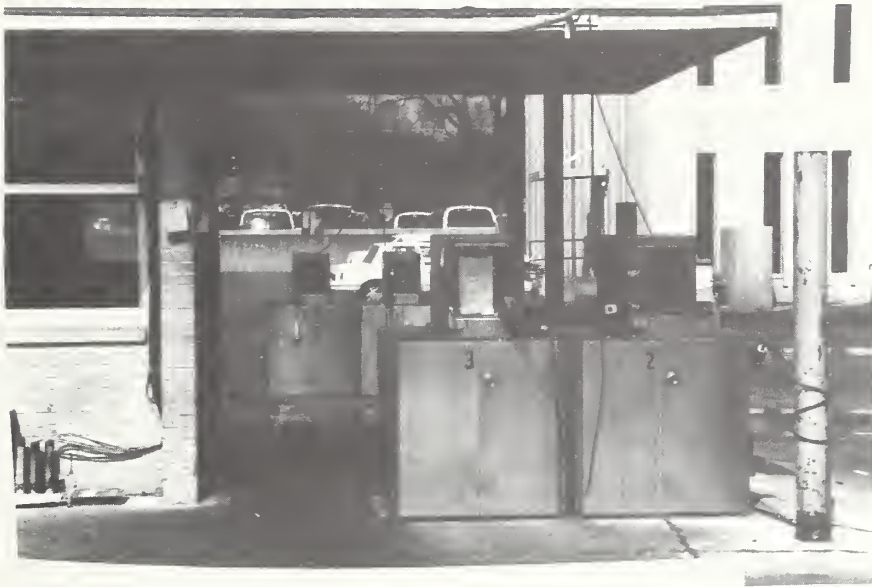
FIGURE 2-12. VAULT RECEIVERS AT DALLAS TRANSIT SYSTEM

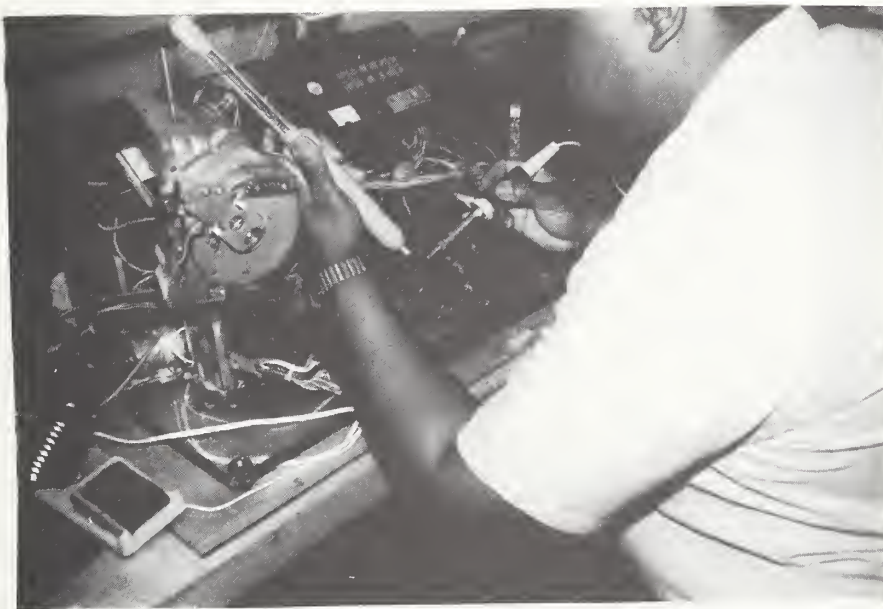
FIGURE 3-6. SEPTA FAREBOX TECHNICIAN
SOLDERS CHASSIS CIRCUIT BOARD

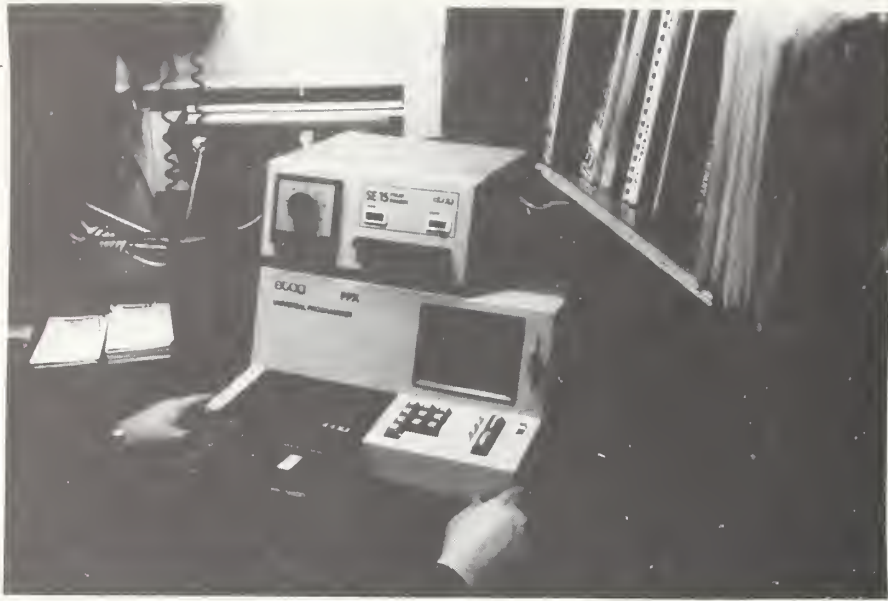
FIGURE 3-7. UNIVERSAL PROM PROGRAMMER
AT MSBA

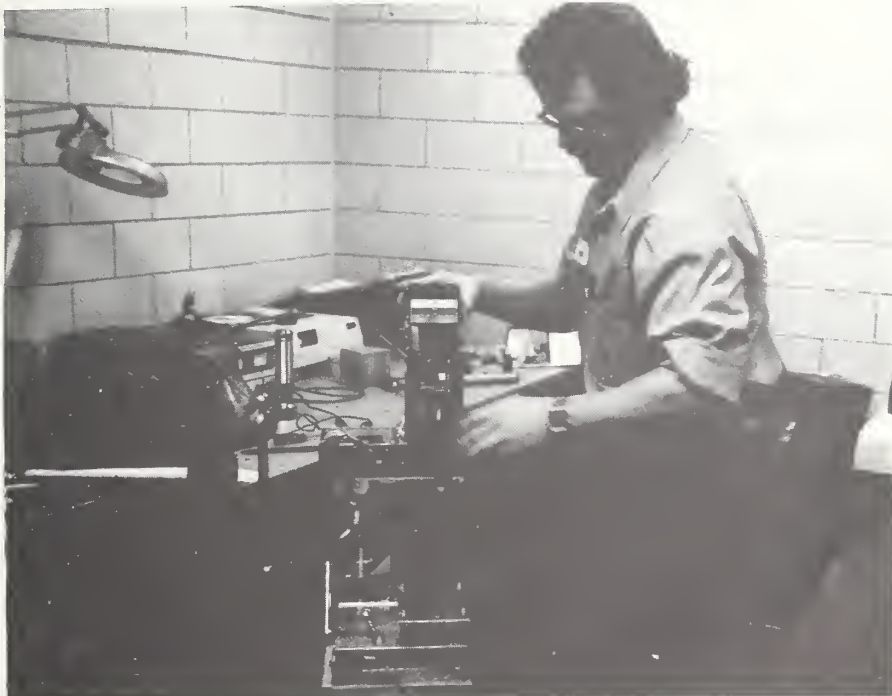
FIGURE 6-1. BILL TRANSPORT BEING REMOVED FOR PREVENTIVE MAINTENANCE AT DALLAS TRANSIT SYSTEM

Maintenance technicians at all four transit systems consider all of the farebox modules to be easily accessible. When asked what module is most inaccessible, most technicians mentioned the bill transport, since both the coin mechanism and the electronic chassis have to be removed before the bill transport can be accessed. Figure 6-1 shows a technician removing a bill transport for preventive maintenance.
